The circular economy of cars

Turku University of Applied Sciences

# Glass dismantling test report

Glass recovery from end-of-life vehicles

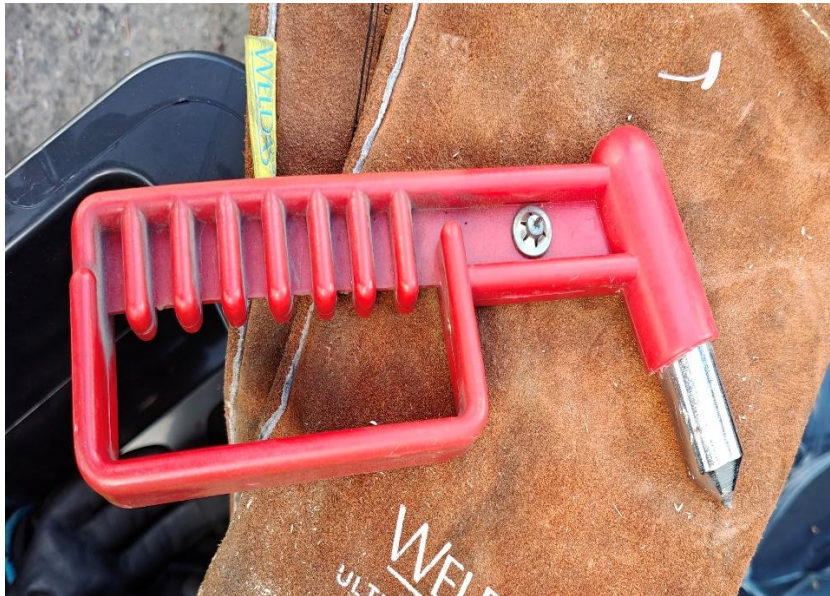
A car safety hammer was used to break the glass. It proved to be an efficient and safe tool for the job. The hammer enabled a fast work phase, and the glass was able to be shattered in a controlled manner. It was easy to use and required minimal physical force.

Picture 1. Car safety hammer.

At the beginning of the test, a spring-loaded glass breaker was also tested, but it proved to be impractical. The breaker went through the window along with the user's hand and arm, which posed a safety risk.

The window was broken with a safety hammer, and the glass shards fell into the trolley or onto the plastic mat. The glass remaining in the frames was removed with a pry bar. If the side windows were attached to the car's body, a plastic mat was used.

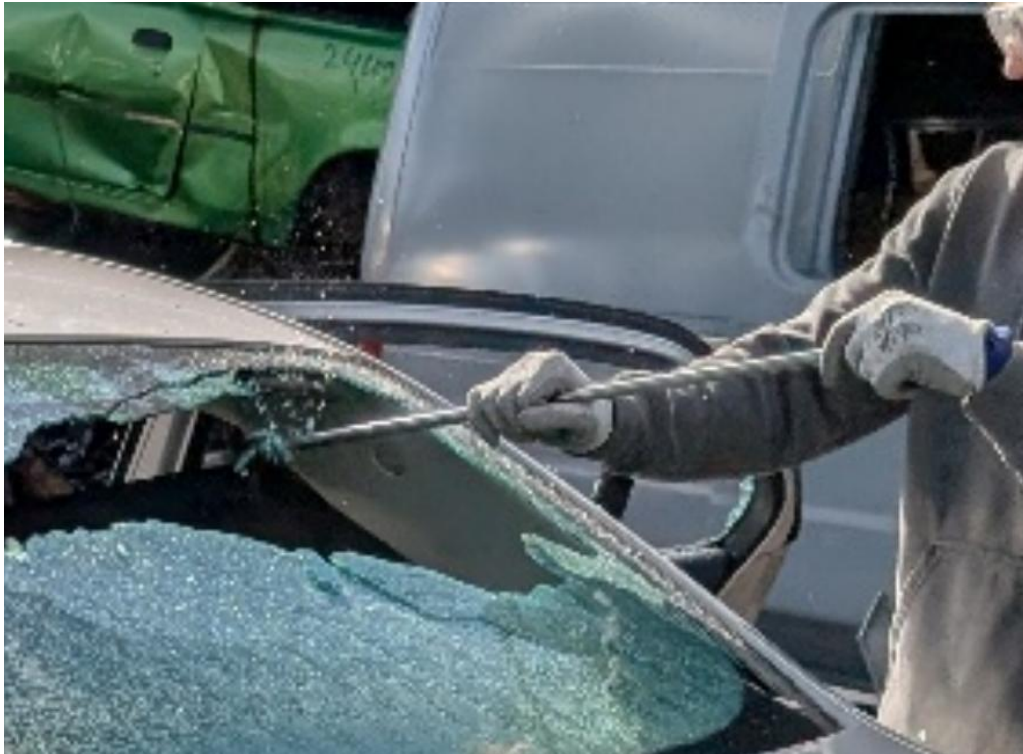
Glass was removed from the window frames and door seals using a steel pry bar. The tool worked well for removing the remaining glass, and its use required minimal physical force. Since glass almost always remained in the window seals, using this tool was essential.

Picture 2. Steel pry bar.

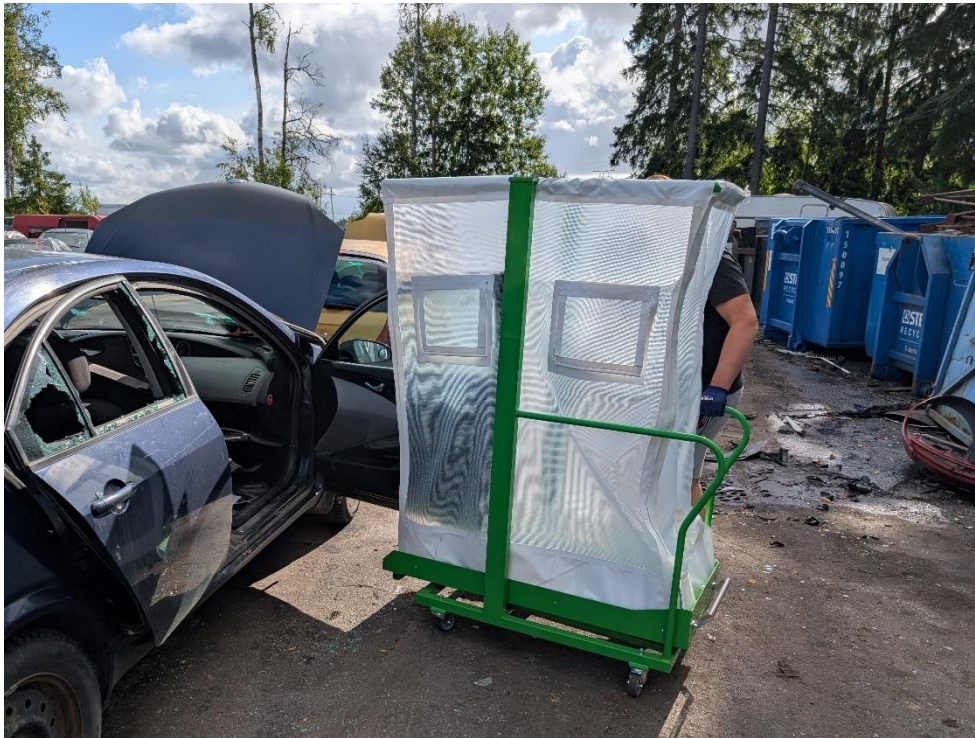
The glass trolley is designed for car doors. The trolley is equipped with wheels, which make it easy to move around. The bottom of the trolley serves as a collection surface for the glass shards, and its mobility allows the glass to be tipped from the trolley into a collection bin. The trolley features a fixed safety cover that encloses the sides of the car door, except for the hinge side. The

safety cover protects the user and the environment from glass shards during the breaking process. The purpose of the cover is also to guide the glass shards onto the collection surface.

Picture 3. Glass trolley.

The usage process of the trolley is as follows: The trolley is pushed under the car door, which requires opening the door completely. Once the safety cover encloses both sides of the car door, breaking the glass can begin. The glass is broken through the openings, allowing the largest shards to fall onto the trolley's collection surface. Any glass remaining in the door frames and seals is broken using a pry bar.

The trolley works as designed, but there were many identified problems with its use. The trolley could not fit under all doors, especially longer ones, causing glass shards to fly into the surroundings. For cars missing their wheels, the trolley could not fit under the doors at all.

The biggest problem was the spreading of glass. The safety cover did not fully enclose the door, especially on the hinge side. Glass flew out of the trolley during both the breaking process and while moving the trolley, which negatively affected the collection rate and compromised occupational safety. The trolley was also difficult to move due to glass shards on the ground.

Additionally, the safety cover was not transparent, which made the breaking process and accurately positioning the trolley under the door difficult. It was hard to see the door's position from behind the trolley, reducing work accuracy and ergonomics. Lifting the bottom of the trolley, i.e., the collection surface, from the floor level was physically demanding and ergonomically challenging, especially during repetitive work.

The collection cart design could be further improved by adding a closed or partially enclosed section on the hinge side to reduce the escape of glass fragments during the breakage process. Furthermore, the collection surface could be equipped with a fixed or mechanically assisted lifting mechanism to minimize physical workload and improve operator ergonomics. The incorporation of a transparent protective cover would enhance visibility and thereby facilitate accurate cart positioning and improving the efficiency of the glass fragmentation and collection process.

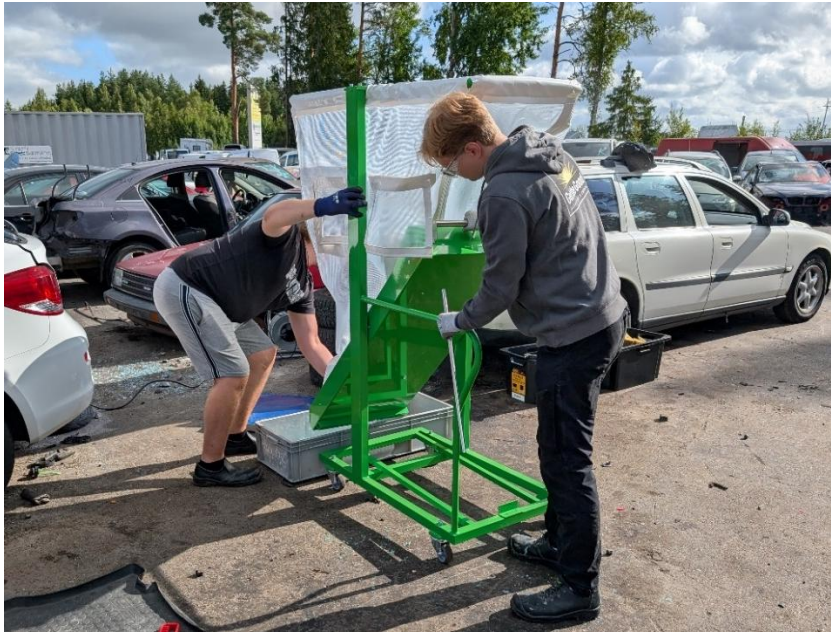
Picture 4. Pouring glass out of the cart.

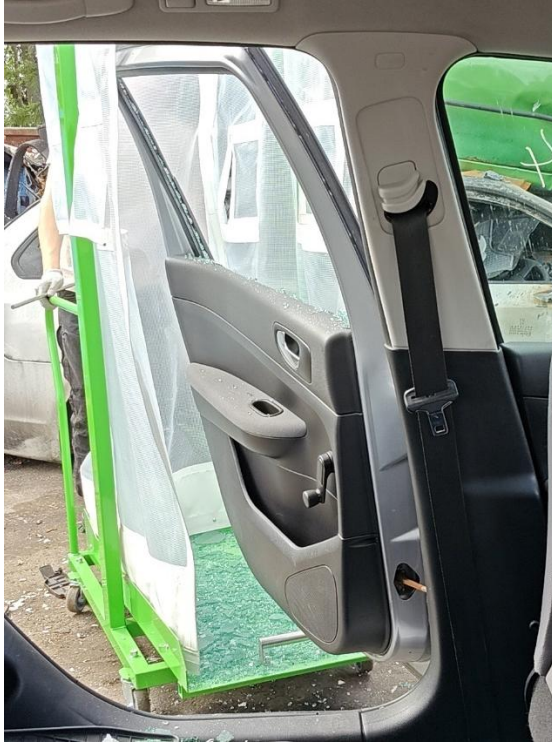
Picture 5. The car door inside the cart.

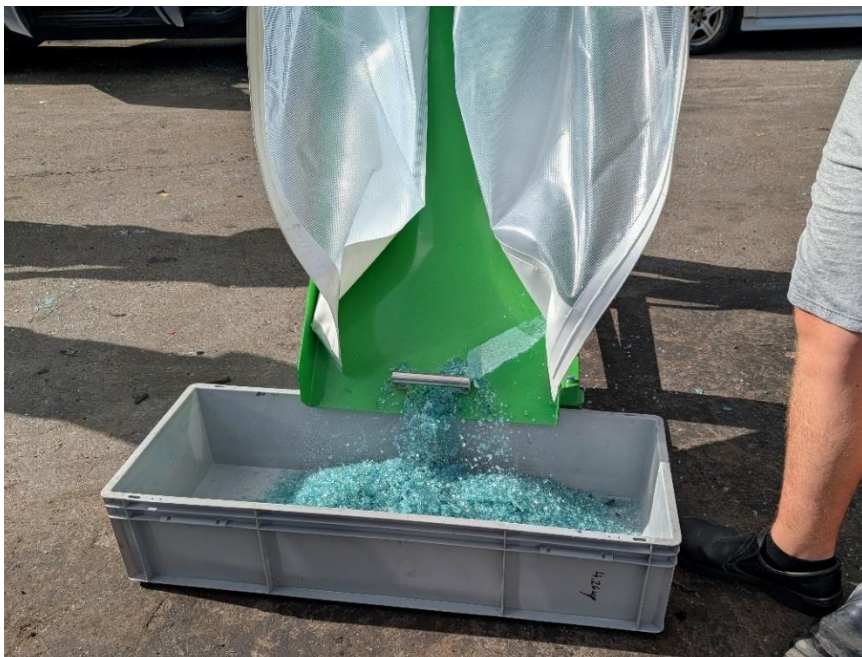
Picture 6. Glass crumb in collection container.

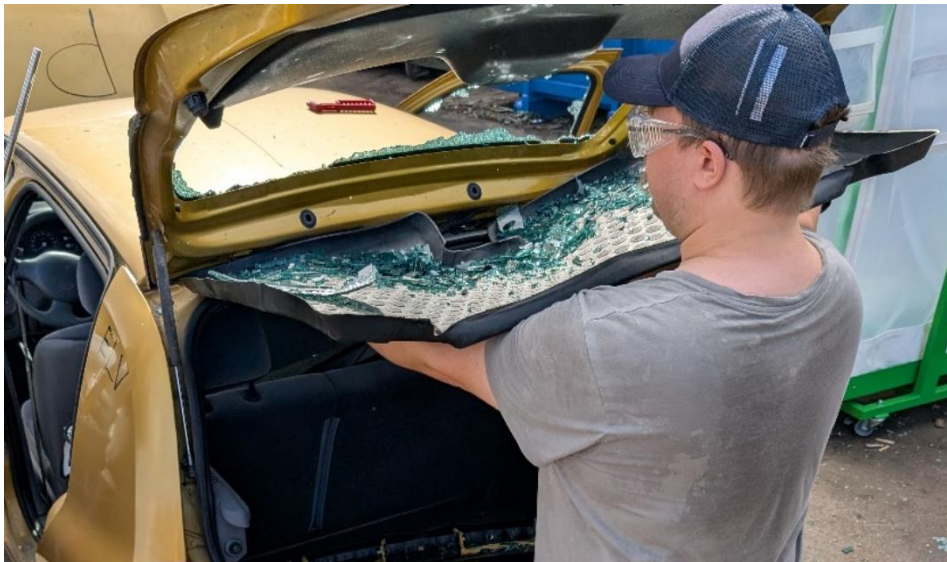
In some cases, especially when the glass was attached to the car's body (e.g., side and rear windows), a plastic mat was used to collect the glass. The mat was placed next to the window inside the car so that most of the shards would fall onto it. The mat was easy to move, making it particularly suitable for situations where the rear window is attached to the body. However, the mat did not prevent the glass from spreading into the surroundings; shards fell during both the breaking and collection processes.

Picture 8. Plastic mat and rear glass.

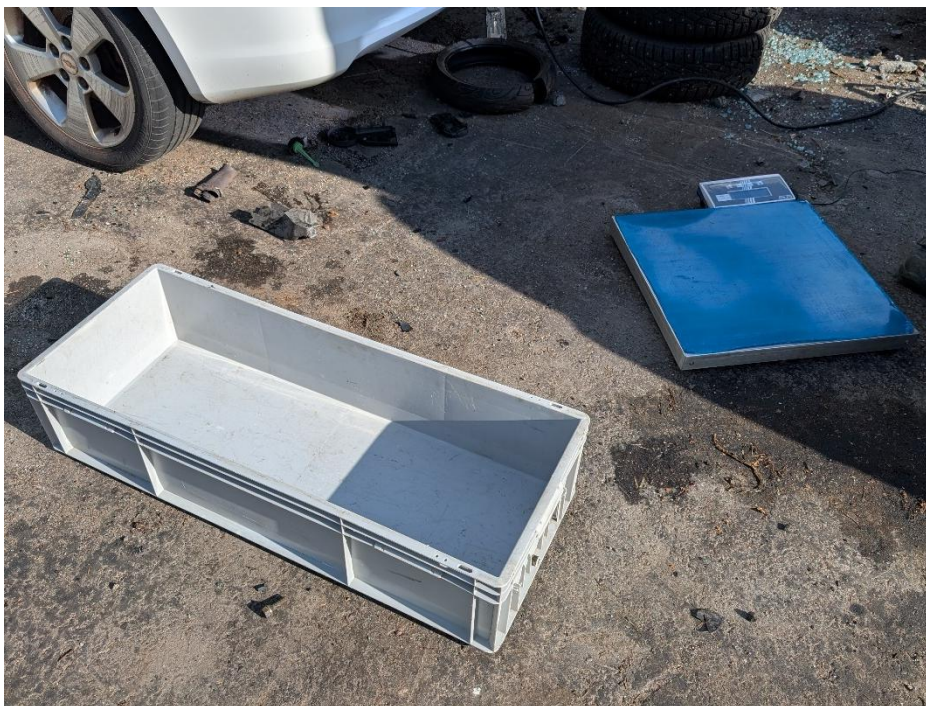
A platform scale was used to measure the weight of the collected glass. This allowed the glass to be weighed directly during the collection phase without a separate transfer step. The crushed glass was tipped from the collection trolley into a pre-weighed collection bin placed on the ground.

Picture 9. Collection container and platform scale.

The collected glass was weighed using a platform scale, which enabled accurate and efficient weighing after the collection phase. The weighing process proceeded as follows. Before the actual weighing, all used measuring bins were weighed, and their weights were recorded. This allowed the calculation of the net weight of the collected glass material.

Once the glass was in the measuring container, the container was placed on the platform scale. The scale displayed the total weight, from which the tare weight of the container was subtracted to obtain the exact weight of the glass.

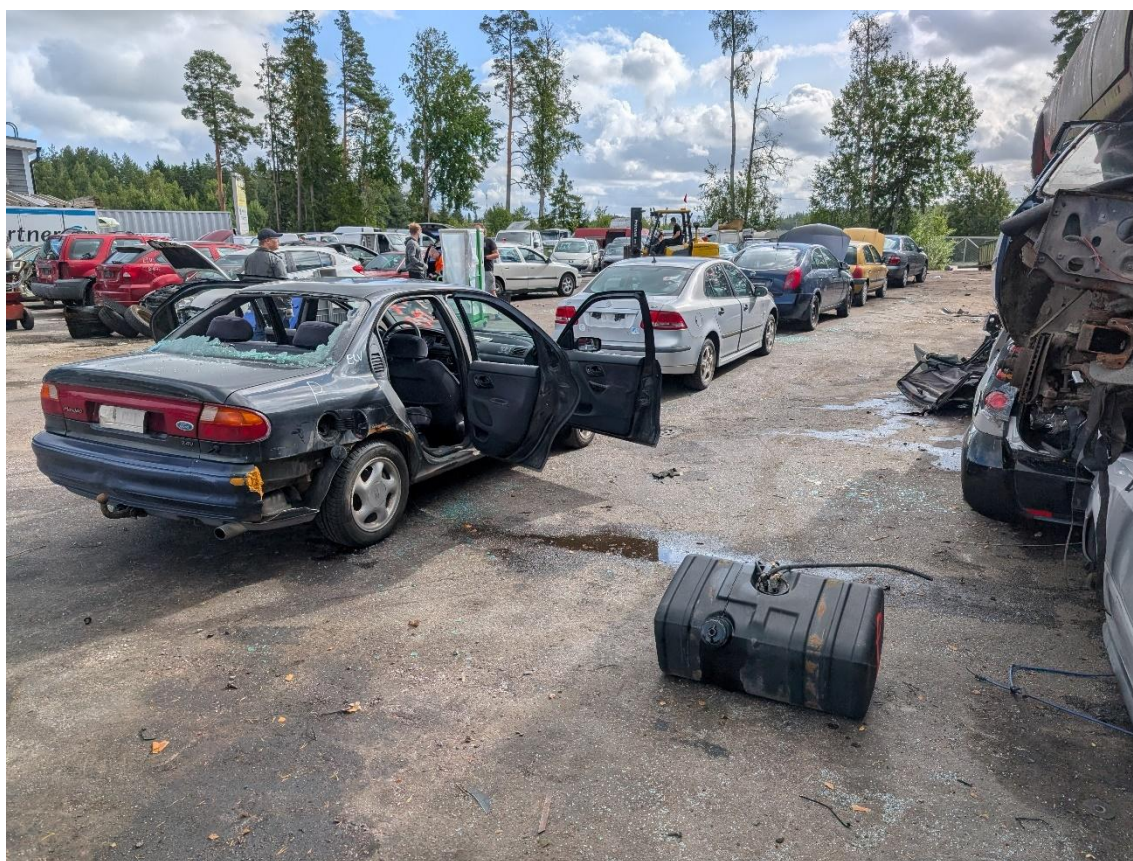
The test was conducted on a total of 25 End-of-Life Vehicles (ELVs). The vehicles were depolluted and positioned in a queue using a forklift and the details of each vehicle were recorded prior to the commencement of the work. The study sample consisted exclusively of four-door passenger vehicles. All vehicles had intact side windows and rear windows. The test was performed by a two-person team.

Picture 10. Cars in queue.

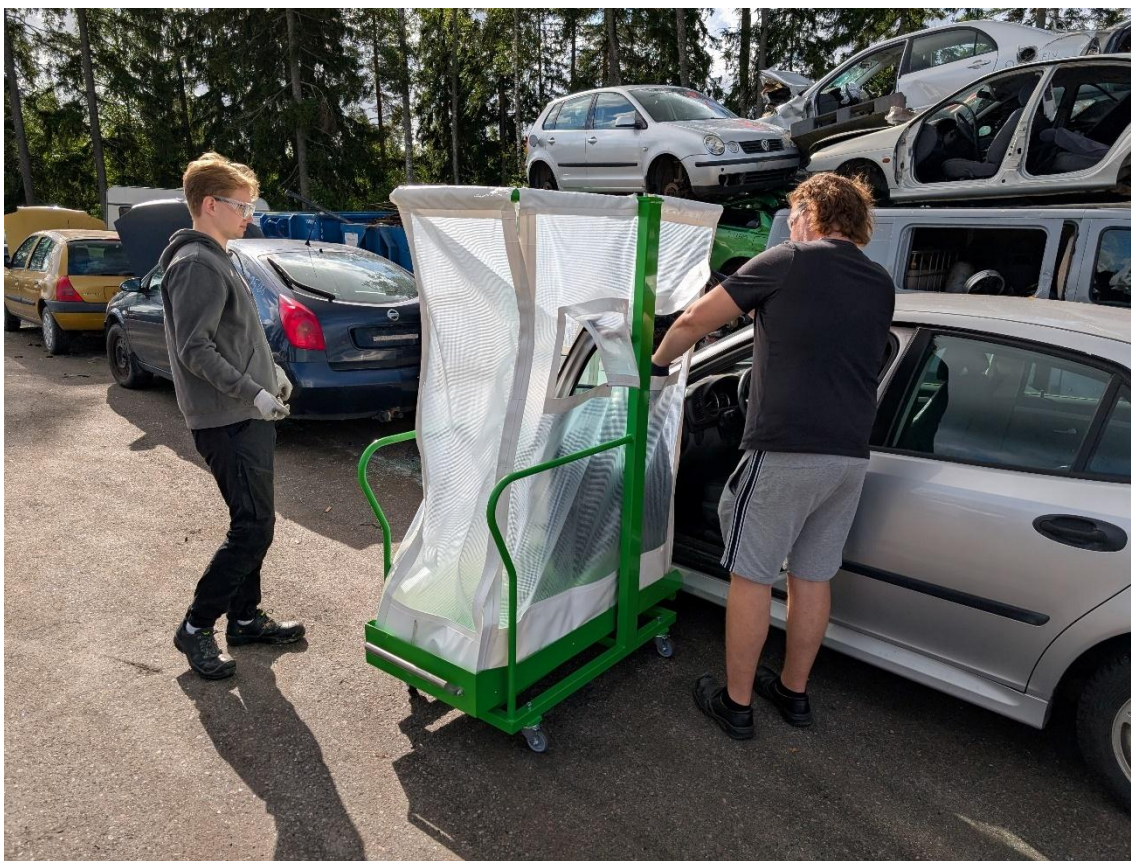
The glass collection process proceeded as follows. The collection time was recorded separately for each vehicle and commenced when both workers were positioned at the designated starting point. The workers then proceeded to the vehicle with the necessary equipment to collect the glass. After all glass, excluding the windshield, had been removed and collected, the workers returned to the starting point. The collected glass was transferred to a weighing container and the timing was stopped. The glass was subsequently weighed and then transferred to a collection container.

Picture 11. Collecting process in progress.

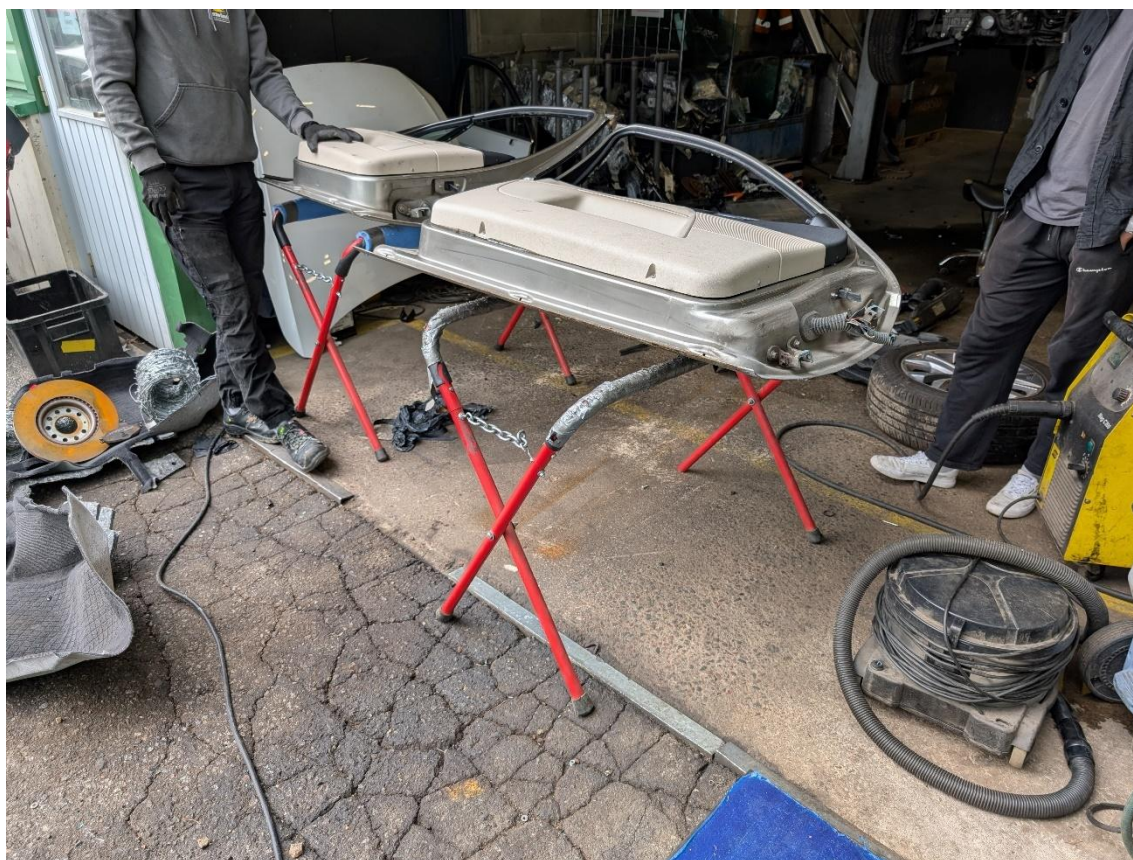
In addition, a detailed assessment was conducted on two vehicles to determine the amount of glass remaining within the door structure after glass removal. For this purpose, the side doors were dismantled, and the interior door trim panels

and window seals were removed. Residual glass fragments were collected from the door cavities and window frames using an industrial vacuum cleaner and subsequently weighed.

Picture 12. Doors ready to be taken apart.

During the collection test, an average of 12.4 kg of tempered glass was recovered per vehicle. This amount does not include the windshield but consists of the side and rear windows. The amount of glass varied depending on the vehicle type and the structural location of the windows. The amount of glass vacuumed from the door structures averaged approximately 1 kg per vehicle.
